# An earlier location of Sheep Wash Stanch on the Little Ouse

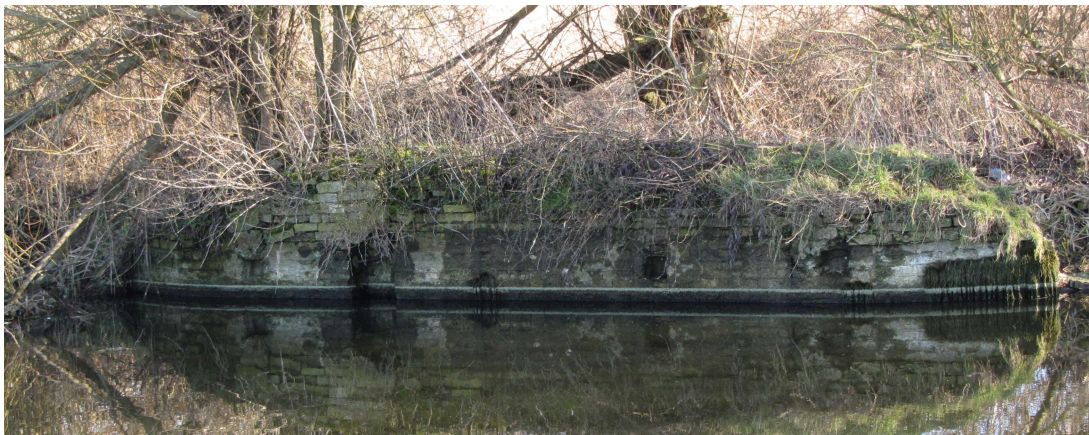
Figure 2: Remains of Sheepwash Stanch as viewed from the north bank of the Little Ouse.  
Photograph taken February 14th 2019

The remains are of masonry, principally brick, and appear to be of one of the bankside piers.

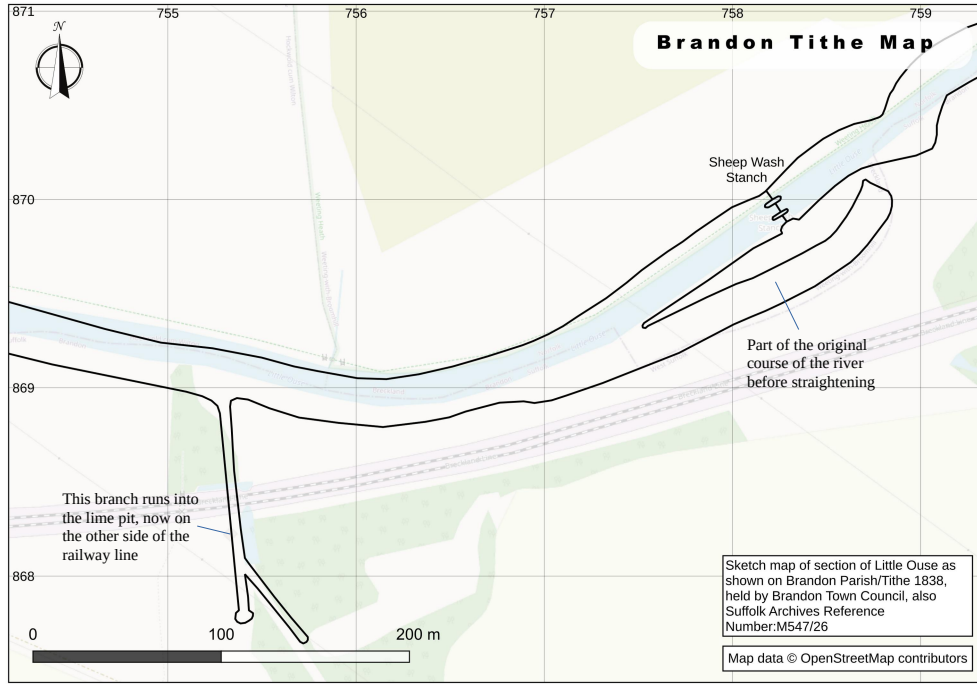
Figure 3: Rough sketch map of section of Brandon Tithe map, 1838.

Two other 19<sup>th</sup> century maps are of interest as they show the stanch and river in the years before the construction of the railway: Brandon Town Council have a copy of the Brandon parish/tithe map of 1838 though now rather fragile. Suffolk Record Office have a copy of this though catalogued as *Map of Wangford Hall Estate near Brandon*<sup>3</sup> Below is overlaid a sketch map on OpenStreetMap as used for the Location map

Both these maps show a dead-end arm of the river south of the stanch and it can be seen that this arm runs close to the line of the Norfolk - Suffolk County boundary where it deviates from the current course of the river.

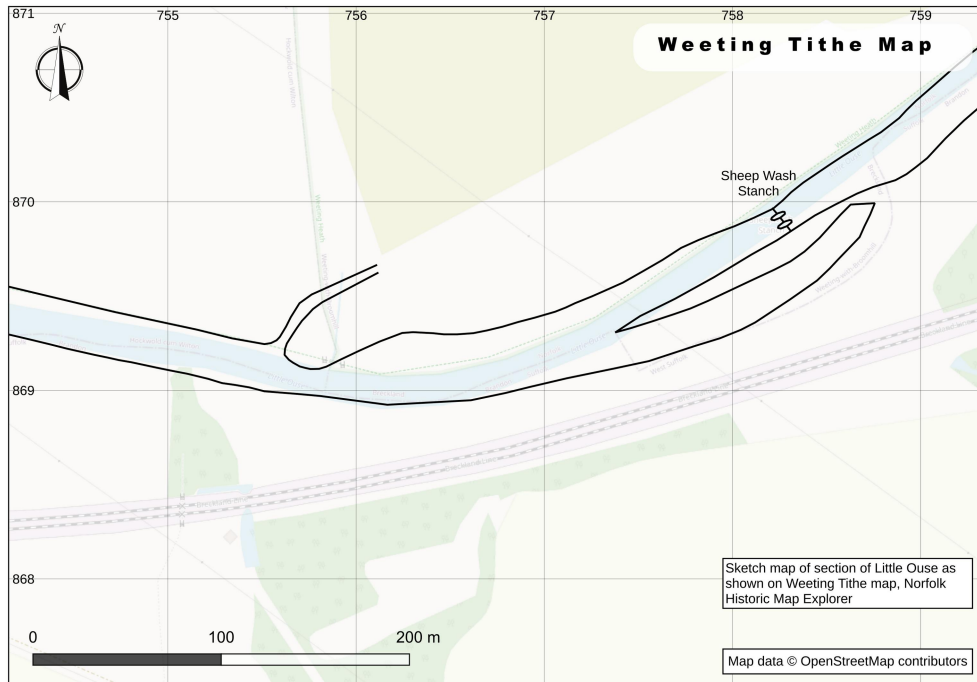
Figure 4: Rough sketch map of section of Weeting Tithe map, 1845

Norfolk Historic Map Explorer<sup>4</sup> has georeferenced tithe maps of Weeting and Hockwold parishes including the river. A similar sketch below:

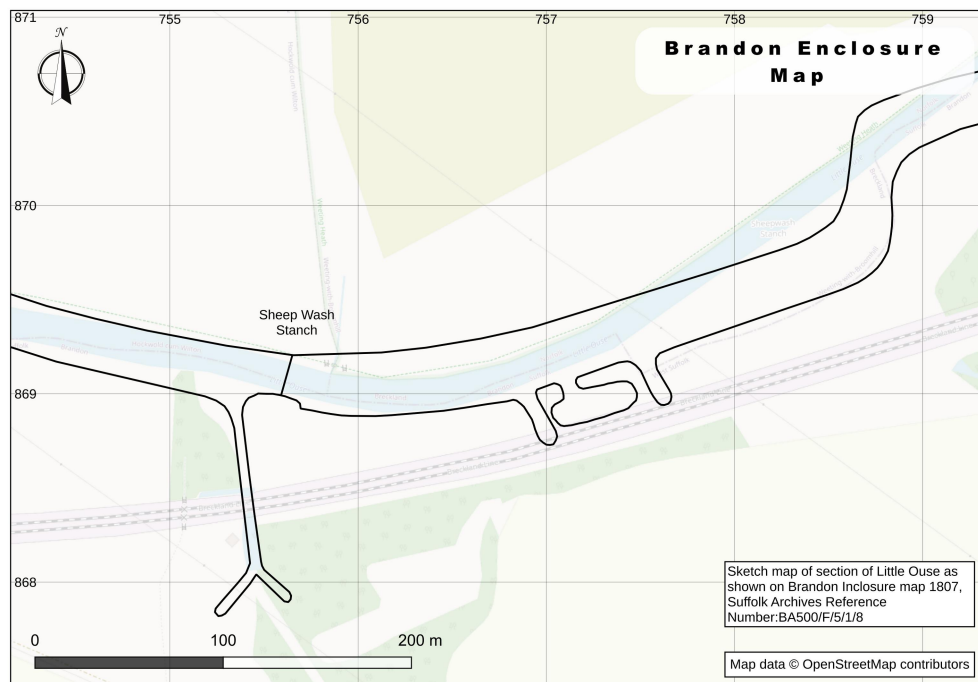
located further downstream, very close to the arm that runs south into the lime pit.

Figure 5: Sketch map of section of Brandon Enclosure map showing the river following the county boundary and the

An earlier map, the Brandon Inclosure map of 1807,<sup>5</sup> shows the river before it was straightened with the stanch

The deviation of the boundary and remains of the original course in the later maps suggest that this section of the river was straightened and the stanch rebuilt on the new, straight cut, and that this occurred sometime between the creation of the Brandon Enclosure map and the tithe maps of the mentioned parishes.
